Site Inspection

**Antelope Valley Pesticide
Container Disposal Site**

**Lander County
Nevada**

FINAL
SITE INVESTIGATION REPORT
ANTELOPE VALLEY PESTICIDE CONTAINER DISPOSAL SITE
LANDER COUNTY

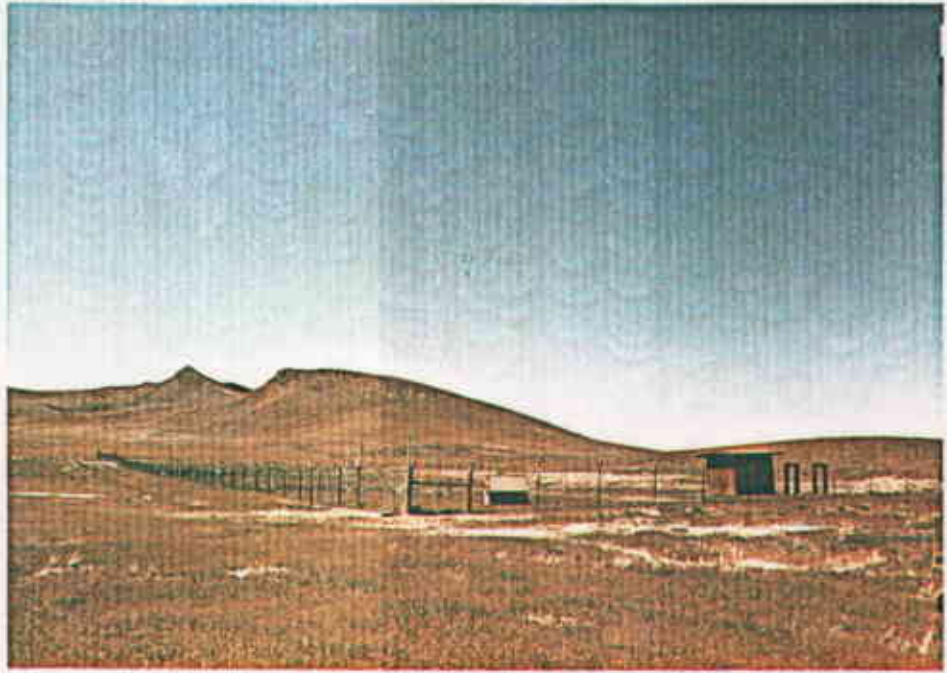
The site is encircled by an 8-foot woven wire fence with an additional two strands of barbed wire strung between back-breakers (angulars) on the top of each post (Figures 2-2 and 2-3a). Access to the site is through a locked gate located in the northeast corner. The key to the lock is under the custody of the Lander County Commissioner, but was made available to a representative of the BLM Battle Mountain District who was present for the on-site activities. The gate and fence are in good condition, but lack posted warning signs. The fence is 417 feet x 209 feet occupying two acres of BLM-owned land. A one to two-foot earth berm surrounds the fence to divert surface runoff around the site.

Figure 2-3a Antelope Valley Site. View is southwest with the Bridges Hills in the background.

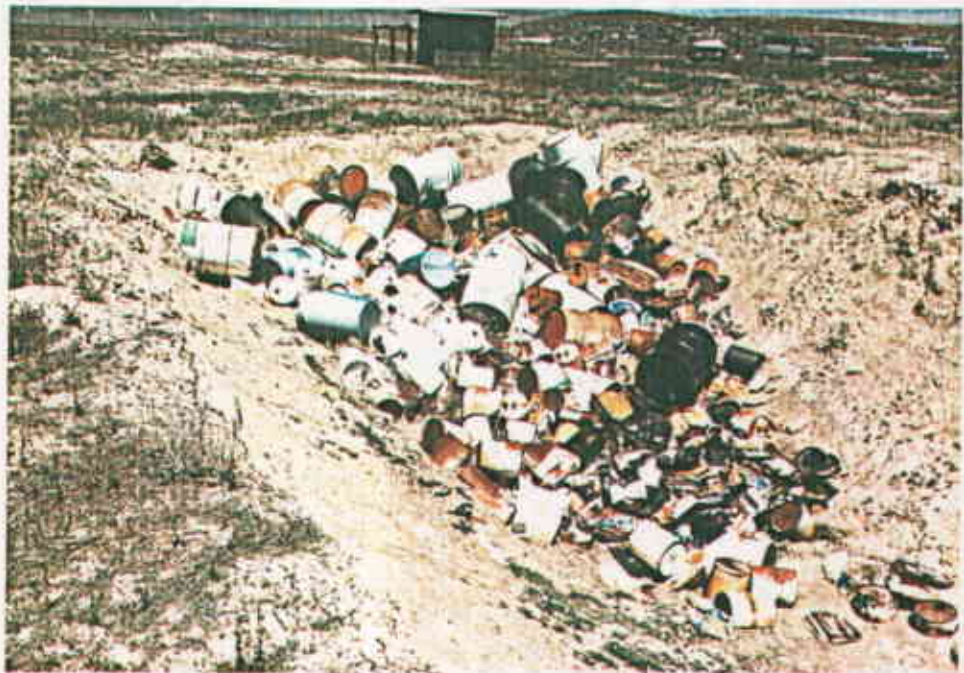
The site contains one disposal trench approximately 35 feet away from the western fence (Figure 2-3b). The trench is approximately 119 feet x 27 feet x 10 feet with an additional 37 feet of backfilled material on the northern end. The trench is ramped to the south, and present disposal is confined to the northern 20-25 feet. Lack of any rubbish other than the permitted containers indicates the site adequately restricts general public access. Two empty storage sheds and a trellis suspected to be used for rinsing the empty pesticide/herbicide containers are located near the northern fence. Shed #2 has been upset and appears to have moved. No sumps were identified and it is unknown if additional sumps are planned.

Figure 2-3b Active Disposal Pit. View is northeast.

The active disposal pit was the only area identified during the site investigation to contain hazardous chemicals. The active disposal pit is approximately 119 feet long with an additional backfilled section extending northward for approximately 37 feet. No other disposal pits were identified during the SI. The operating plan called for sumps to be constructed to collect water used to rinse the containers. No sumps were visibly identified during the SI. As noted, the waste containers occur only in the northern 20-25 feet of the pit.

No records of the quantity, types of containers or exact dates of disposal have been maintained on site. Containers vary from one gallon glass jars to five gallon plastic and steel buckets to 55 gallon plastic and steel drums. Site practices do not follow the operating procedure since many of the steel drums have not been crushed. The lack of identifiable sumps and over-all neglect of the sheds and rinse station area suggests the containers are not being rinsed on-site prior to disposal. Furthermore, approximately six glass one gallon jars labeled as Dibrom 8 Spray containing liquids were visibly identified in the pit. This occurrence is not in accordance with operating procedures and should be addressed. The soil at the backfilled section of the pit is settling around and into the containers posing the potential hazard of collapsing under site personnel.

The disposal pit is not lined and is constructed within native soils at the site. The pit does not contain a leachate collection system and it has been inadequately backfilled with native soil. The fence and gate are sufficient for limiting access, but warning signs should be posted.

WESTON recommends closure of the active disposal pit to restrict further waste accumulation. Closure activities should involve excavation of the containers and either transport and disposal at a permitted facility or re-disposal on site in a lined pit. Transport and disposal is more desirable to mitigate the long-term liability. Sampling beneath the excavated waste pile should be conducted to determine if contaminant migration has occurred. All the containers should be crushed to minimize settling of the backfill material and to keep burrowing animals from nesting in the drums.
